United States  
General Accounting Office  
Washington, D.C. 20548

B-240653

January 29, 1991

On April 19, 1989, 47 sailors died when five bags of propellant ignited in the open chamber of the center 16-inch gun of the battleship U.S.S. Iowa's turret II. The Navy's investigation concluded that the explosion resulted from a deliberate act and not from a defect in the gun or propellant.

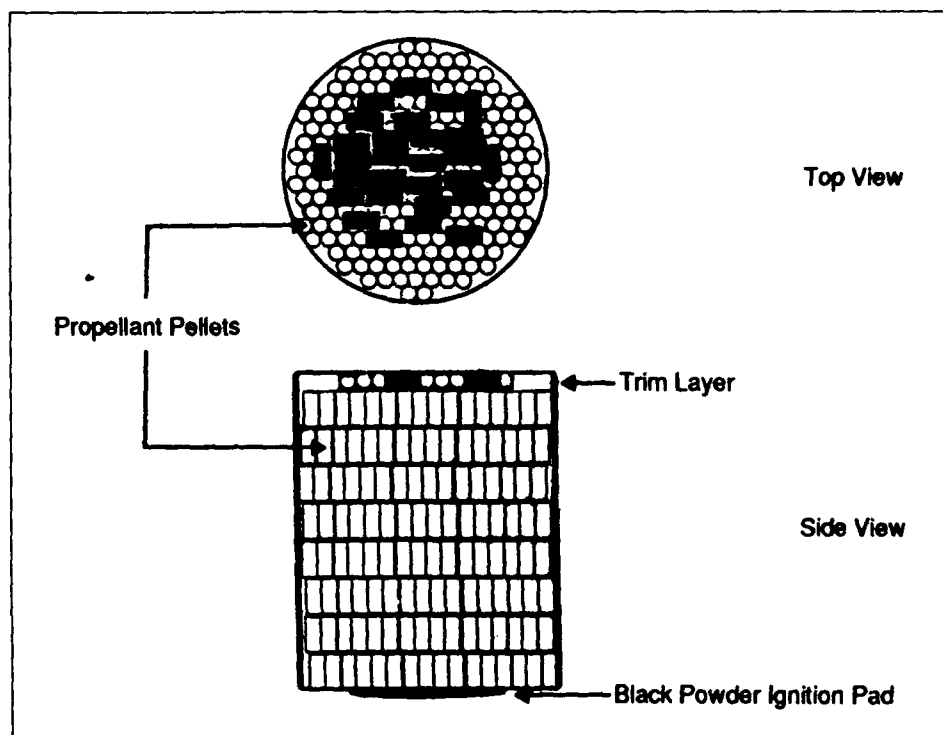
**Figure 1.3: Powder Configuration of the Type of Powder Involved in the Iowa Explosion**

While it agreed with the Navy that the powder was chemically stable and confirmed that a significant overram of the powder charge had occurred, Sandia identified a plausible alternative explanation of the cause of the explosion. It believed the forces generated by overramming the powder charge against the base of the projectile can fracture pellets in the bags' top layer releasing burning particles that may ignite the black powder in the adjacent powder bag and, in turn, ignite the whole charge. Sandia believed that the probability of this process occurring depends on the speed of the overram and the number of pellets in the top layer.

The powder for the 16-inch guns is contained in silk bags. Six bags are the standard charge to fire a projectile. Each bag of the type of powder involved in the Iowa explosion contained about 94 pounds of propellant pellets. As shown in figure 1.3, these pellets are stacked vertically in the bag in eight layers. Each bag also contains a trim layer that consists of a variable number of propellant pellets placed horizontally on the top layer of vertically stacked pellets when necessary to standardize the weight of the charge. Additionally, a pad containing black powder is sewn to the base of the bag.

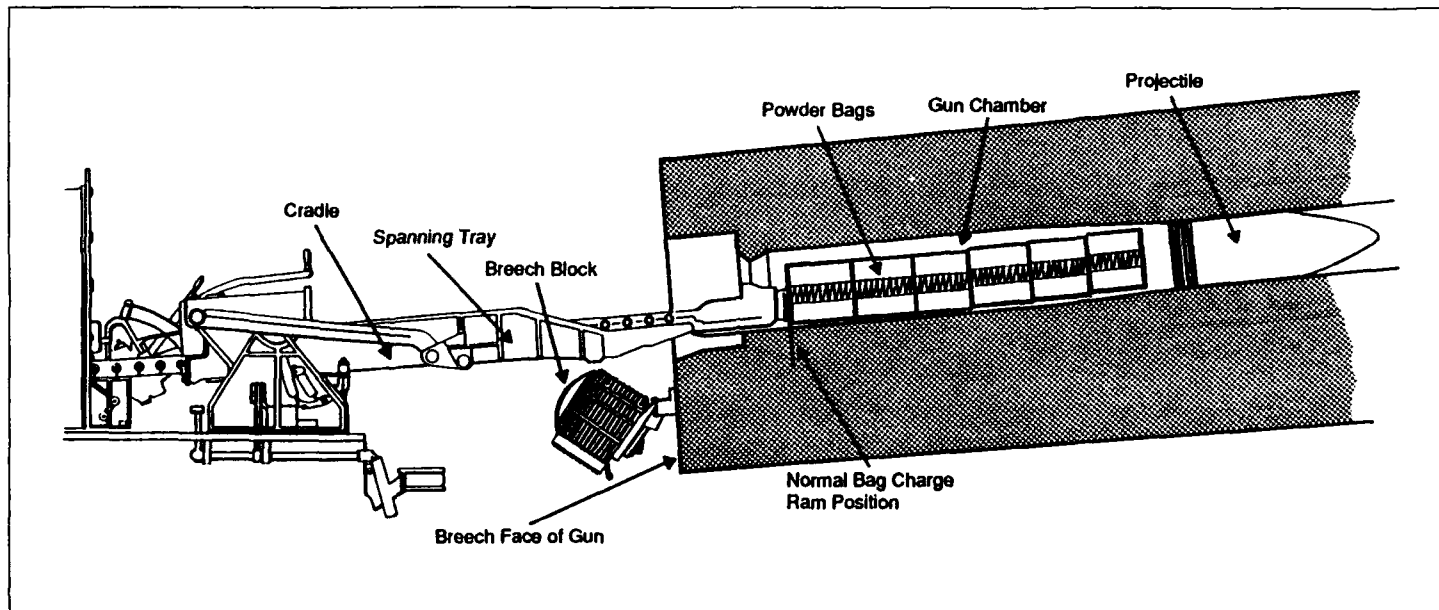
Figure 1.4: Gun and Rammer

Both the projectiles and the powder are loaded into the 16-inch guns using an electric-hydraulic rammer mechanism (see fig. 1.4). The projectile is loaded first, after which the powder bags are loaded. A crew member, responding to hand signals from the gun captain, controls the speed and length of the ram with a manually operated lever. Projectiles are to be rammed at a speed of about 14 feet a second, while the powder charge is to be rammed at about 1 to 2 feet a second. When a gun is fired, the black powder of the bag closest to the breech block is ignited by the primer, which ignites the propellant.

While the Navy's report stated the powder had only been rammed about 21 inches too far, Sandia concluded from its analysis of the damage the rammer chain caused as the chain was blown out of the chamber that the powder had been rammed about 24 inches too far. According to Sandia's analysis, the longer overram compressed the powder charge against the base of the projectile before it ignited.

Sandia made three recommendations in its report. First, it recommended that the 16-inch guns be equipped with a mechanism to control the speed of the rammer and the placement of the powder bags. Second, it recommended that the powder bag be redesigned to eliminate the need for a trim layer to reduce the propellant's sensitivity to impact. Third, it recommended that further testing be conducted to fully define the safe limits of pellet configuration, bag compression, rammer speed, and other relevant 16-inch gun and turret operations.

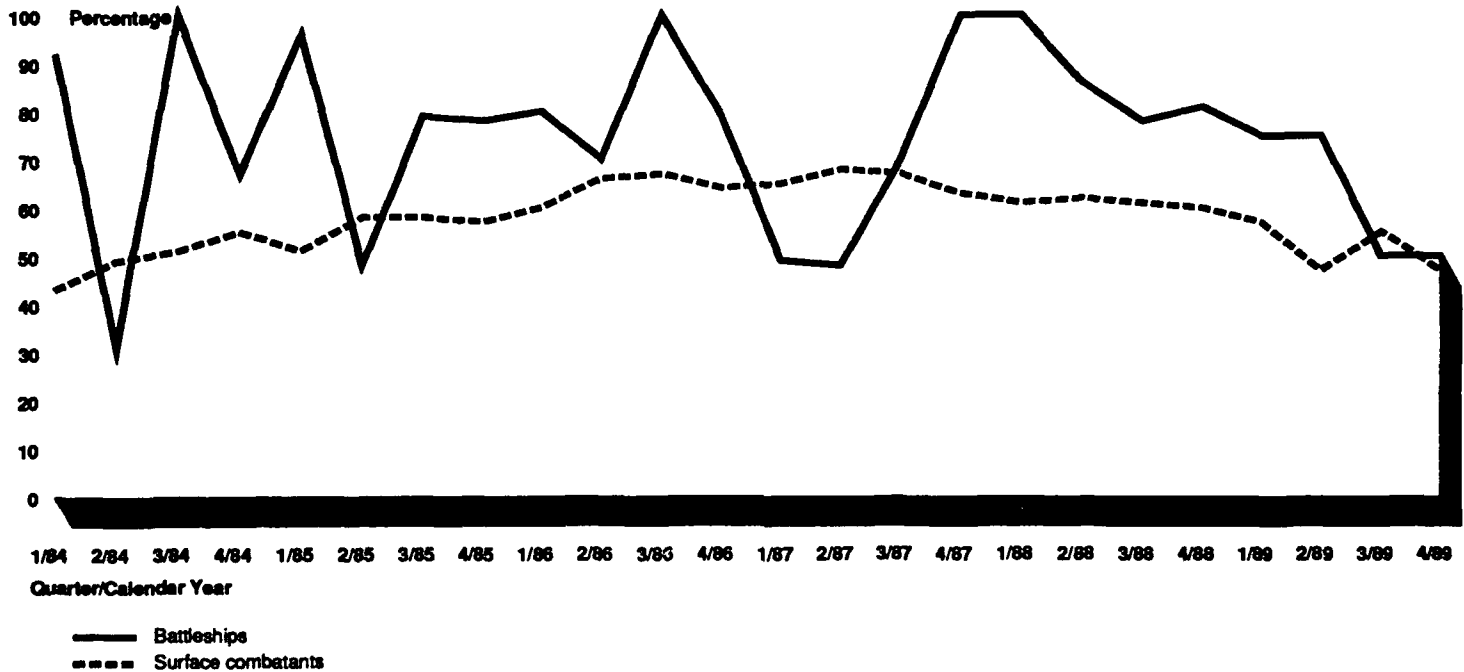
Figure 3.1: Operating Time Free of Serious Equipment Failures

For a broader comparison, we compared the battleships' overall equipment readiness to that of other Navy surface combatants to determine if the battleships, as a group of ships, present any undue material or supply support problems. As figure 3.1 shows, between 1984 and 1989 the battleships operated without any failures that had a major impact on or precluded the ships from performing a primary mission for a substantially greater percentage of time than did surface combatants as a whole. The battleships had the better record in this regard for 19 of the 24 quarters in this period. Additionally, the battleships reported no failures of this severity during four quarters. During the period covered by the comparison, the number of battleships in commission increased from one to four while the total number of surface combatants ranged from about 180 to about 200. The battleships' experience showed more variation than did the surface combatants because of the small number of battleships in commission.

There were no distinct overall differences between the battleships and the surface ships in the proportion of the total number of equipment failures due to the unavailability of repair parts, about 62 percent of the total failures in each case. However, only about 3 percent of the battleships' total supply-related failures had a major impact on or precluded the ships from performing a primary mission while about 11 percent of the supply-related failures for all surface ships were so categorized.
